5.0 Falls City, Texas, Disposal Site

5.1 Compliance Summary

The Falls City, Texas, Disposal Site, inspected on January 31, 2007, was in excellent condition. Deep-rooted woody vegetation continues to encroach on the top and side slopes of the disposal cell, requiring control. The turf on the disposal cell top and the remainder of the site appears to have recovered from drought conditions. Groundwater monitoring was performed; historical trends continue. The revised LTSP was submitted to NRC; concurrence is pending. No maintenance needs or cause for a follow-up or contingency inspection were identified.

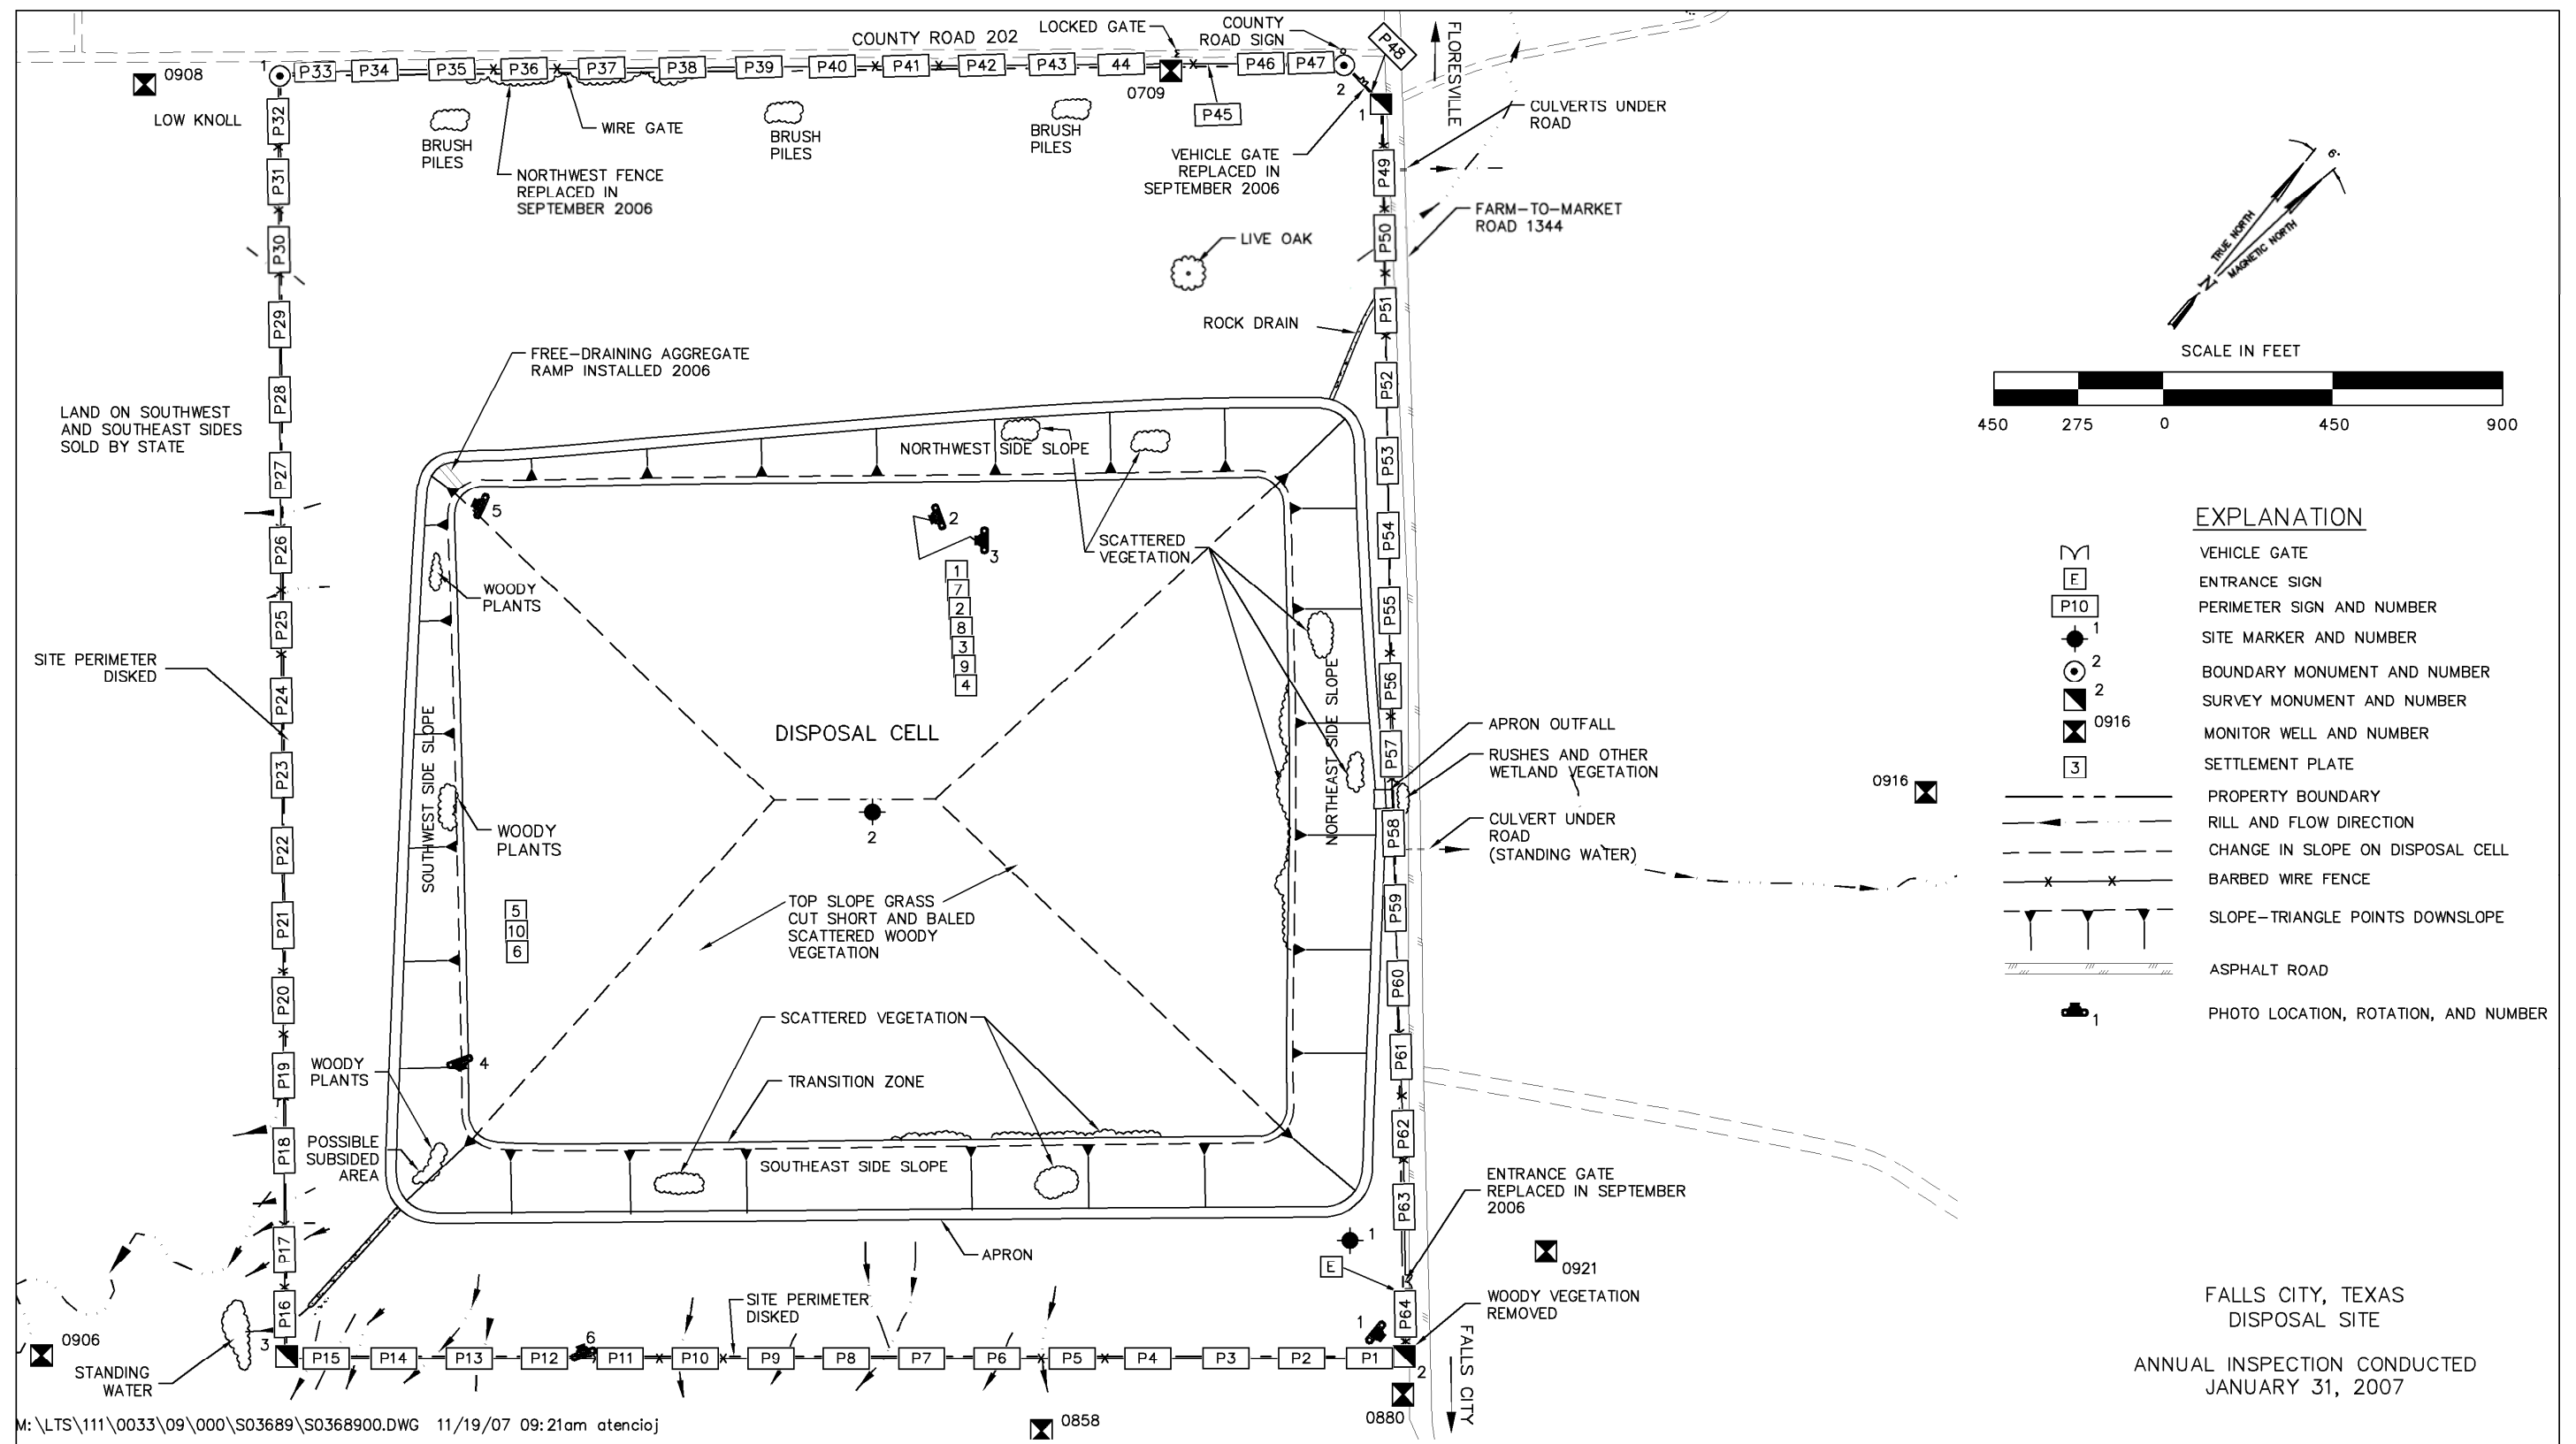
Top and Side Slopes of the Disposal Cell—The top of the disposal cell is covered with well-established grass and in good condition. Occasional mesquite seedlings, a deep-rooted tree, are scattered across the cell top (PL–2). A local rancher cuts hay each year from the disposal site, including the top of the cell (PL–3). The grass on the cell top had been cut short to control the risk of fire. Vegetation is dense and no sparse or barren areas were noted. There are no deep-rooted plants remaining on top of the disposal cell once the grass is cut.

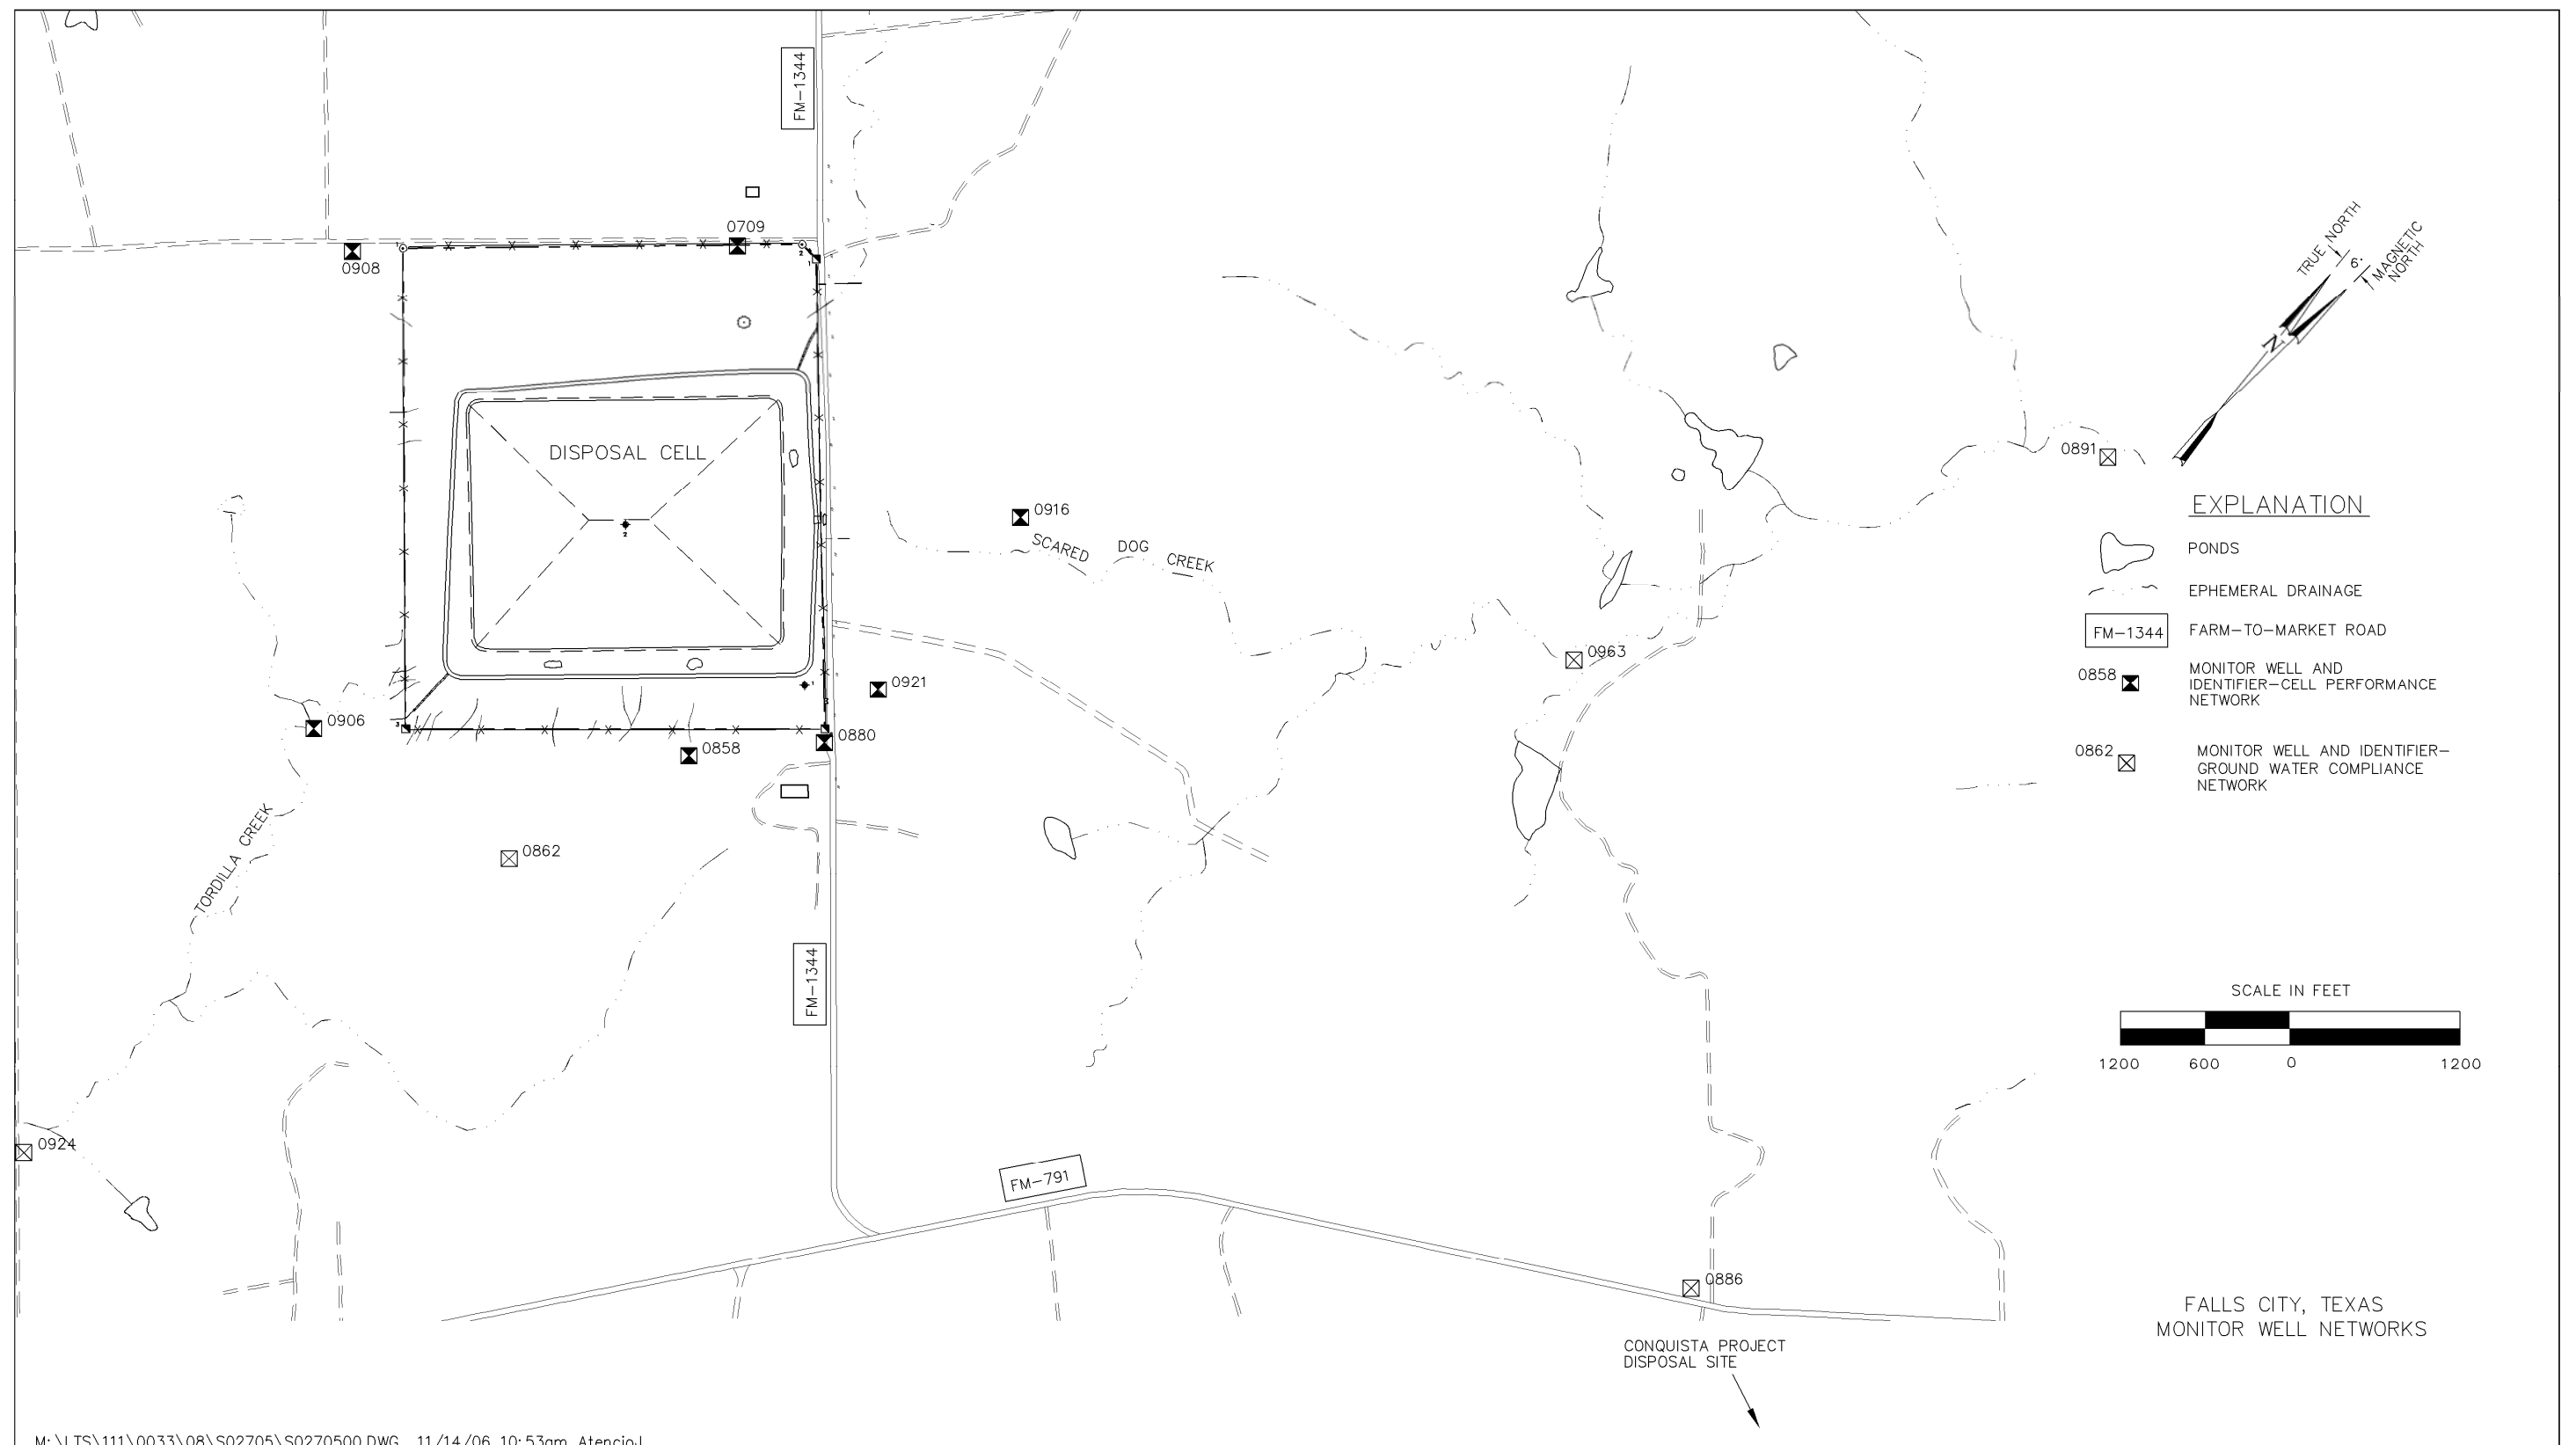
Figure 5-2. Combined Monitor Well Network at the Falls City, Texas, Disposal Site

The disposal cell performance-monitoring network consists of five monitor wells (MW-0709, MW-0858, MW-0880, MW-0906, and MW-0921) that are all completed in the uppermost aquifer and sampled semiannually as specified in the LTSP. Two additional cell performance wells (MW-0908 and MW-0916), also completed in the uppermost aquifer, are designated for water level measurements only.

The groundwater compliance-monitoring network consists of five monitor wells (MW-0862, MW-0886, MW-0891, MW-0924, and MW-0963) that are completed in the uppermost aquifer and sampled annually as specified in the GCAP. The monitor well networks are shown on Figure 5-2.
